A Climate Adaptation Case Study
in Canada's Mining Sector

Enhancing Weather Resiliency at Nyrstar Myra Falls

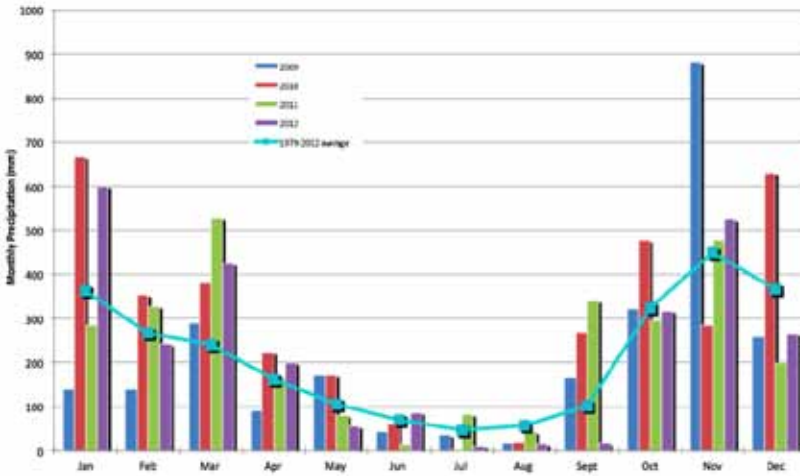
Figure 2 | Nyrstar Myra Falls Precipitation by Month 1979-2012

The Myra Falls mine is affected by a variety of weather-related risks. The mine site is located in a rugged mountainous region that is highly susceptible to weather patterns moving eastward from the Pacific Ocean. Such patterns can bring heavy precipitation,⁴ particularly during the winter months (Figure 2). Dry conditions can also be experienced during the summer and at other times as well, such as the months of October and November 2013 when there was exceptionally low rainfall.

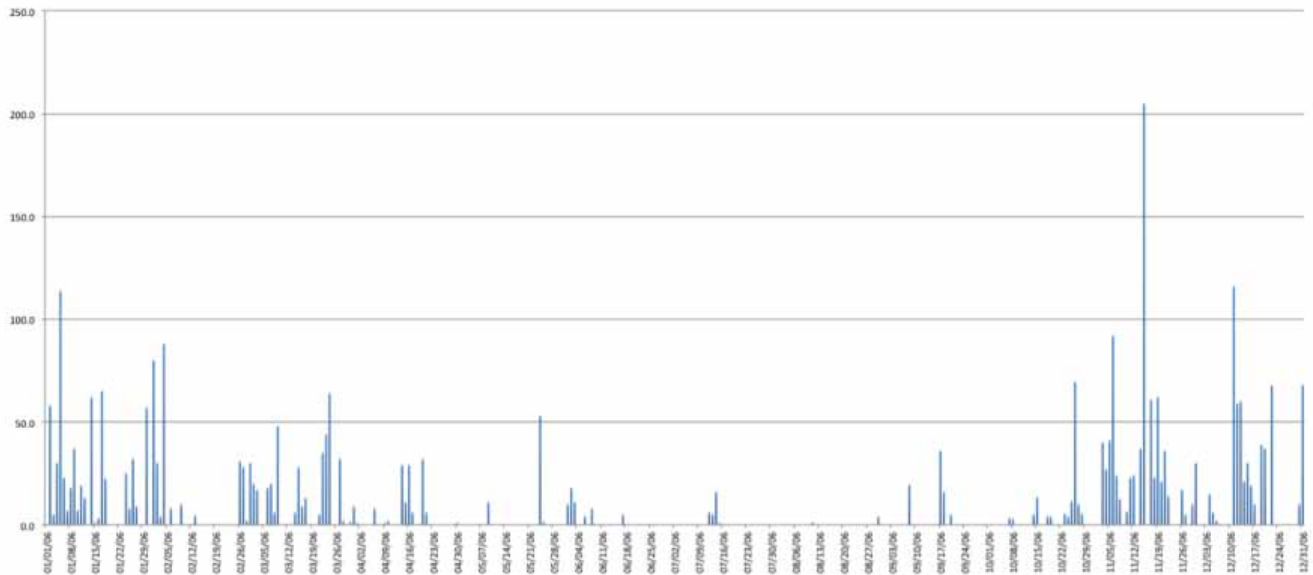
Figure 3 | Total Daily Precipitation – 2006

On November 15, 2006, the Myra Falls mine experienced particularly intense rainfall, characterized as a 1 in 200 year flood event, when approximately 205 mm of rain fell over a 24-hour period (Figure 3).

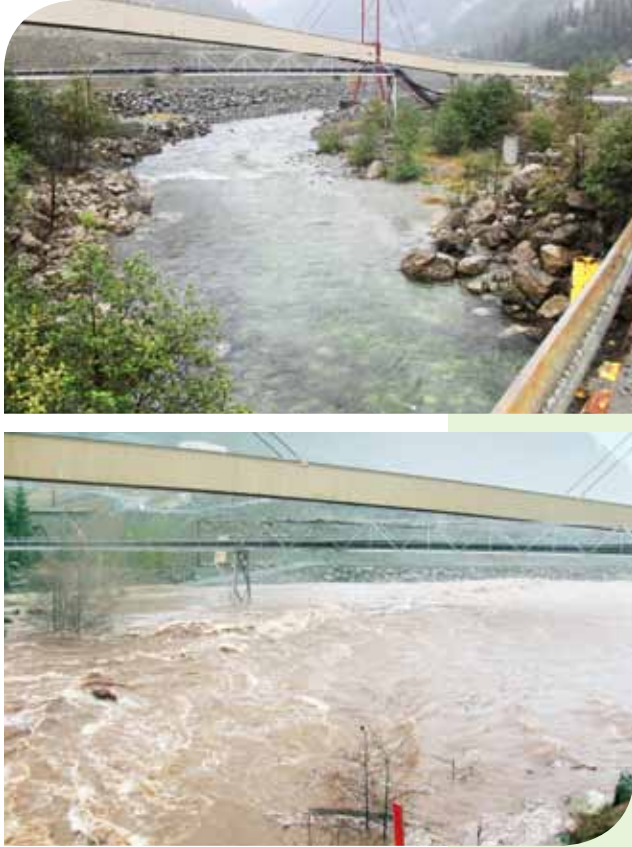
Figure 4 | Top: Normal rain event surface flows (August 2013)
Bottom: November 2006 flows

The event caused extensive flooding (Figure 4) and debris flows (Figure 5), resulting in suspension of operations for five days and damage to key infrastructure including:

- Partial breach of the diversion channel at the top of the mine tailings pond, resulting in large quantities of clean water flowing into the tailings pond and creating a risk of overtopping
- Undermining of hydropower penstock footings
- Damage to footings of a key bridge on the public road through the mine site (Figure 6)
- Washout of the main access road in two locations, completely suspending road access/egress to and from the mine for two days and restricting road traffic for five days
- The mine effluent treatment system being overwhelmed with inflows, causing effluent to back up.

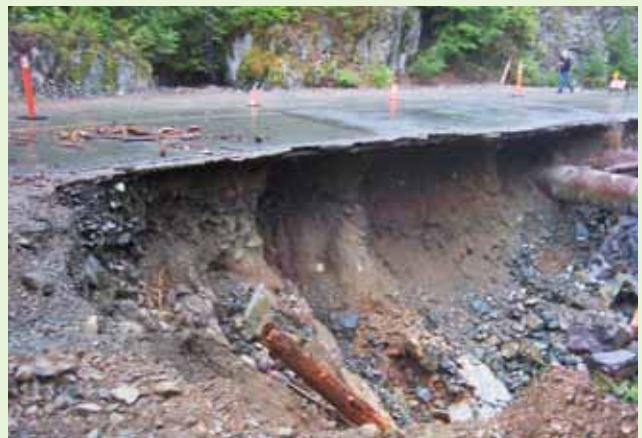
Figure 6 | Damage to main access road

The 2006 flood event had major financial consequences for Breakwater Resources, the owner of the mine at the time. In addition to the \$4M in lost production over the downtime period of five days plus start-up and the construction of a Bailey Bridge to restore the main access road, the company incurred costs of \$250K for emergency pumping equipment. Subsequently, it cost the company approximately \$550K to implement a pumping system designed to handle future events of a similar magnitude and \$100K for a second effluent drainage line.
