A Climate Adaptation Case Study  
in Canada's Mining Sector

# Enhancing Weather Resiliency at Nyrstar Myra Falls

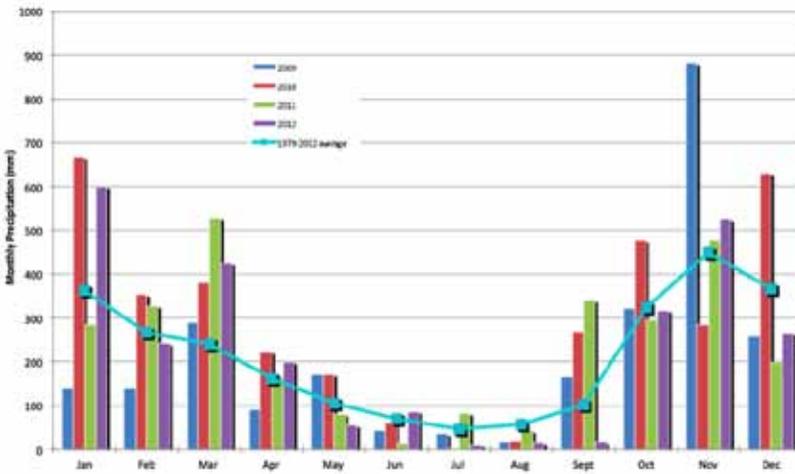
Figure 2 | Nyrstar Myra Falls Precipitation by Month 1979-2012

The Myra Falls mine is affected by a variety of weather-related risks. The mine site is located in a rugged mountainous region that is highly susceptible to weather patterns moving eastward from the Pacific Ocean. Such patterns can bring heavy precipitation,<sup>4</sup> particularly during the winter months (Figure 2). Dry conditions can also be experienced during the summer and at other times as well, such as the months of October and November 2013 when there was exceptionally low rainfall.

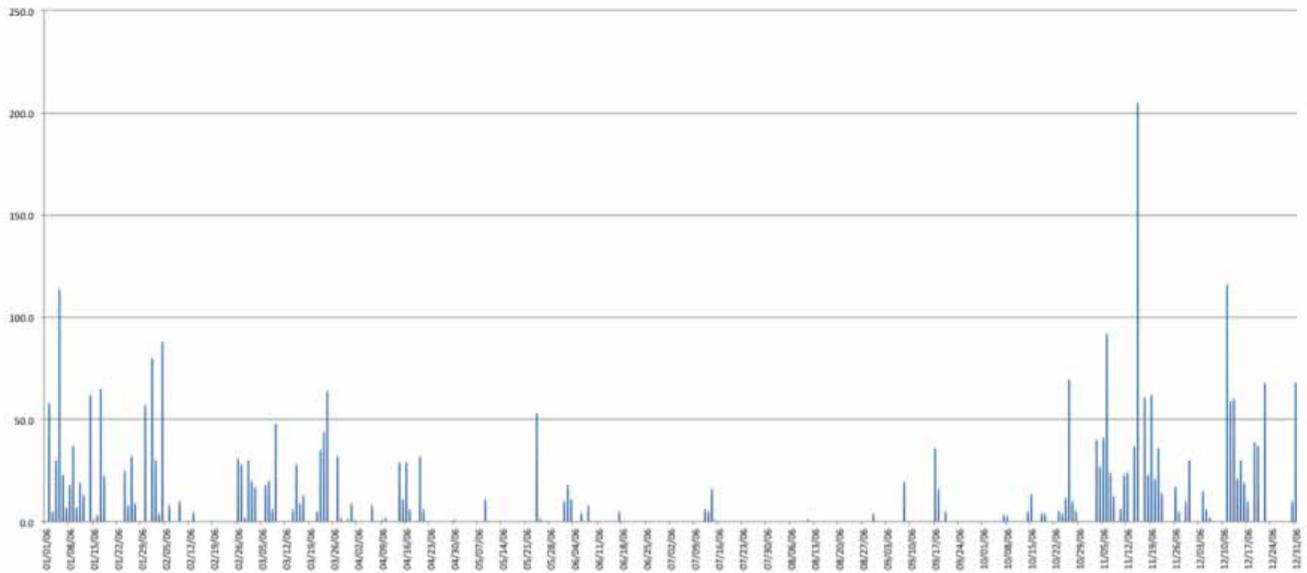
Figure 3 | Total Daily Precipitation – 2006

On November 15, 2006, the Myra Falls mine experienced particularly intense rainfall, characterized as a 1 in 200 year flood event, when approximately 205 mm of rain fell over a 24-hour period (Figure 3).

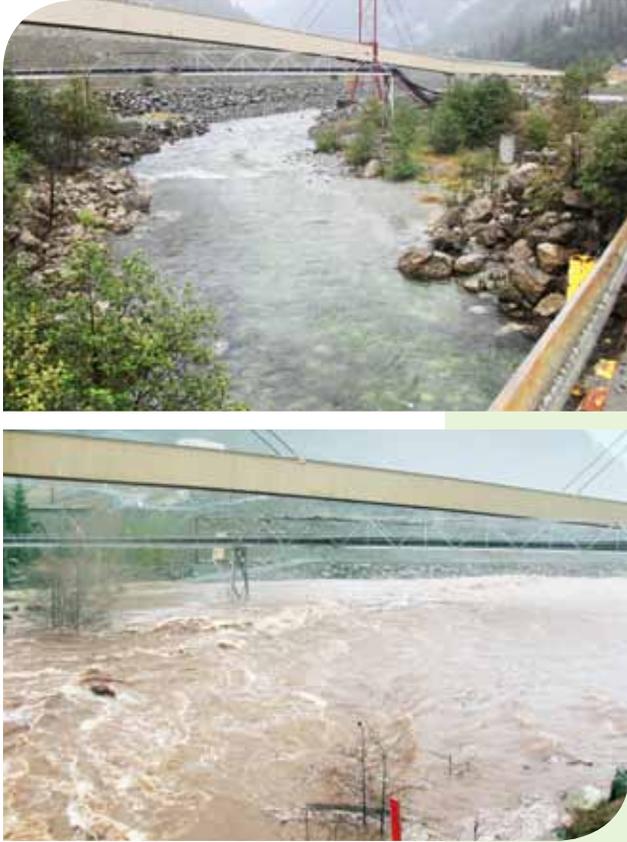
Figure 4 | Top: Normal rain event surface flows (August 2013)  
Bottom: November 2006 flows

The event caused extensive flooding (Figure 4) and debris flows (Figure 5), resulting in suspension of operations for five days and damage to key infrastructure including:

- Partial breach of the diversion channel at the top of the mine tailings pond, resulting in large quantities of clean water flowing into the tailings pond and creating a risk of overtopping
- Undermining of hydropower penstock footings
- Damage to footings of a key bridge on the public road through the mine site (Figure 6)
- Washout of the main access road in two locations, completely suspending road access/egress to and from the mine for two days and restricting road traffic for five days
- The mine effluent treatment system being overwhelmed with inflows, causing effluent to back up.

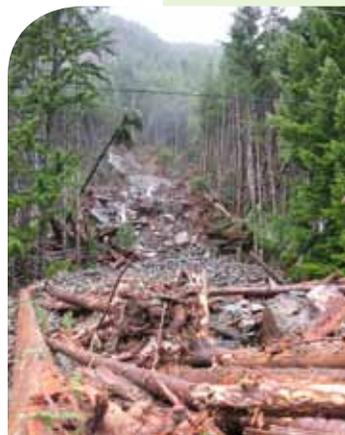
Figure 5 | Example of debris flow in vicinity of Nyrstar Myra Falls mine

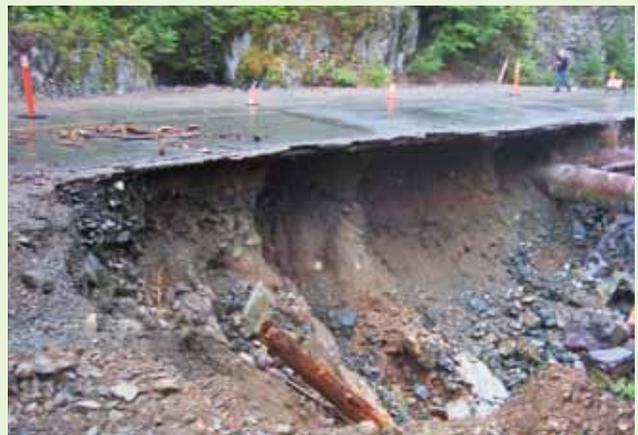
Figure 6 | Damage to main access road

The 2006 flood event had major financial consequences for Breakwater Resources, the owner of the mine at the time. In addition to the \$4M in lost production over the downtime period of five days plus start-up and the construction of a Bailey Bridge to restore the main access road, the company incurred costs of \$250K for emergency pumping equipment. Subsequently, it cost the company approximately \$550K to implement a pumping system designed to handle future events of a similar magnitude and \$100K for a second effluent drainage line.

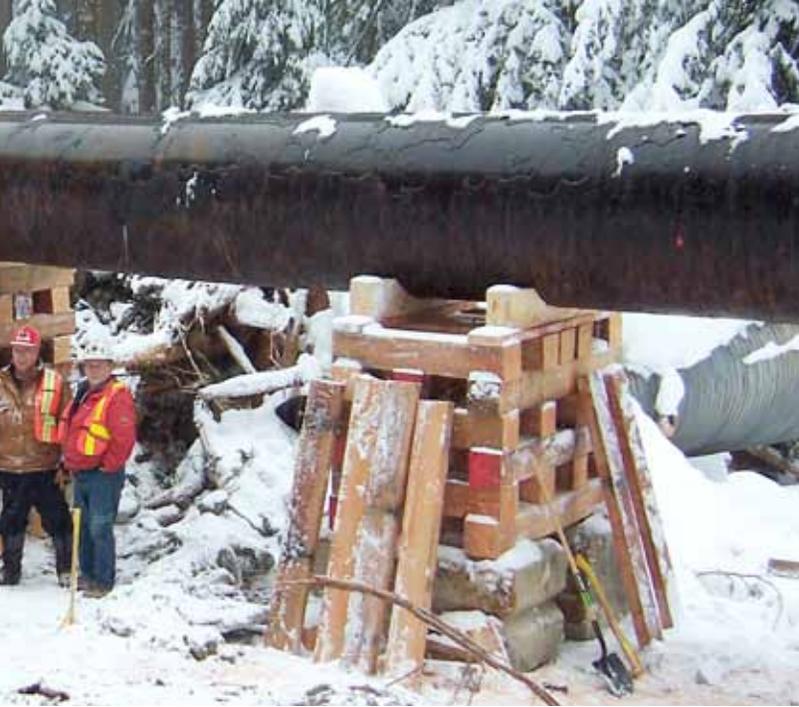
Figure 7 | Repair of damaged hydropower penstock footings

- Suspension of operations and immediate evacuation of the underground
- Dispatch of an excavator to effect emergency repair of the diversion channel above the tailings pond
- Rapid sourcing and deployment of additional pumps
- Repair of penstock footings damaged by runoff and debris flows (Figure 7); and
- Construction of a pipeline routed from the 1500 level underground to surface (to control water flows).
